# *Electrospark Deposition for U.S. Navy Component Repair Applications*

**January 2006 HCAT Meeting  
San Diego, CA**

**NSWC Carderock Division**

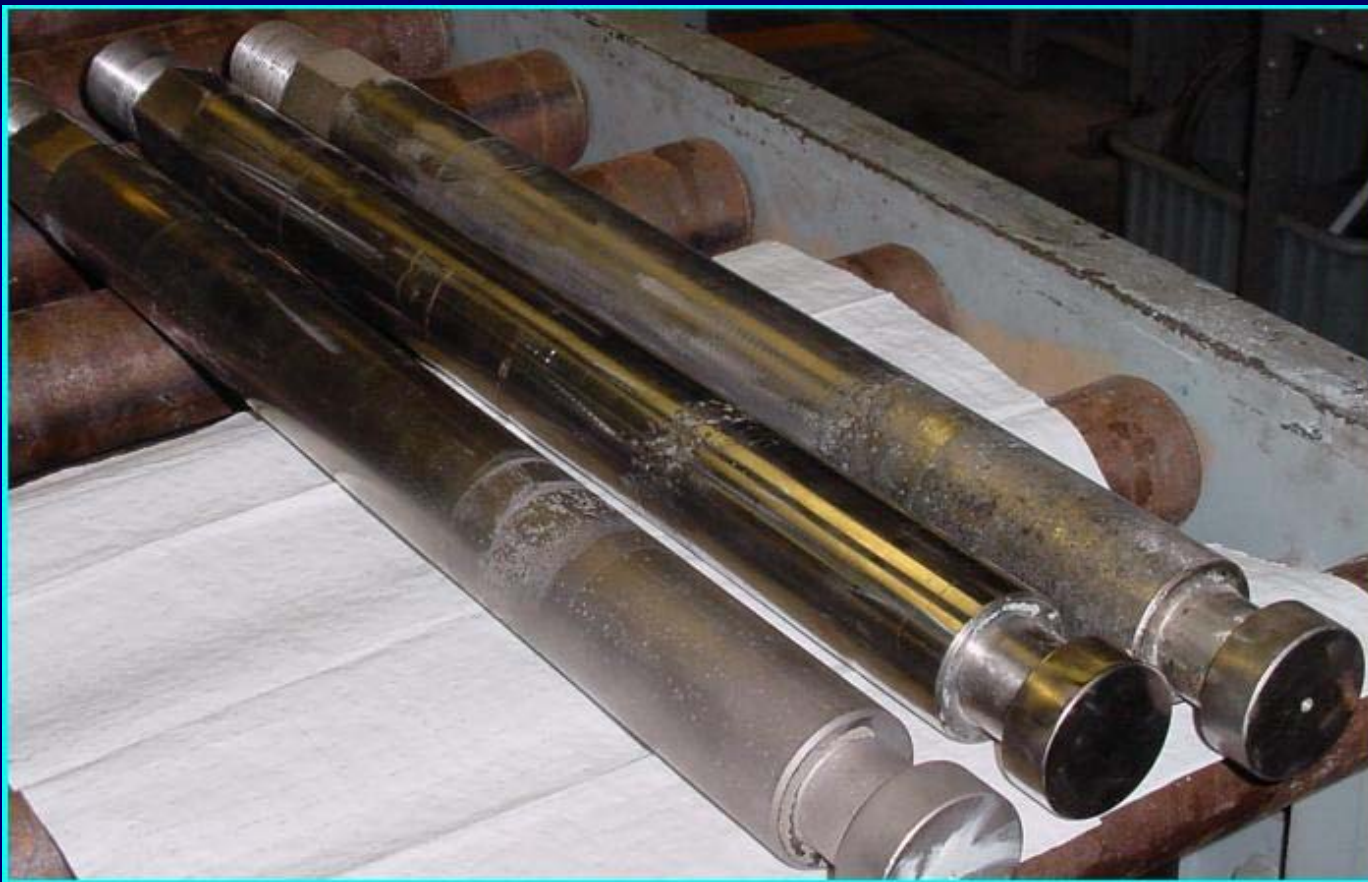
# *Hull Valve Stem*

Unacceptable corrosion/wear of Alloy K500 control rods and valve stems

Electrospark deposition of Alloy 400 to re-establish original dimensions

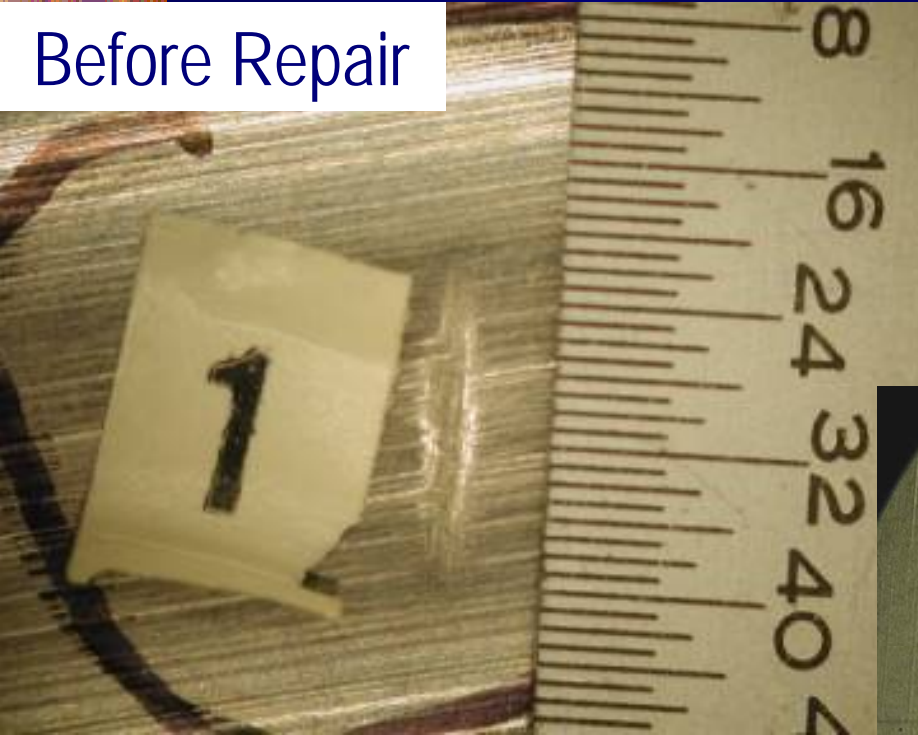
Before Repair

Defect Measured  
0.016" to 0.021" in Depth

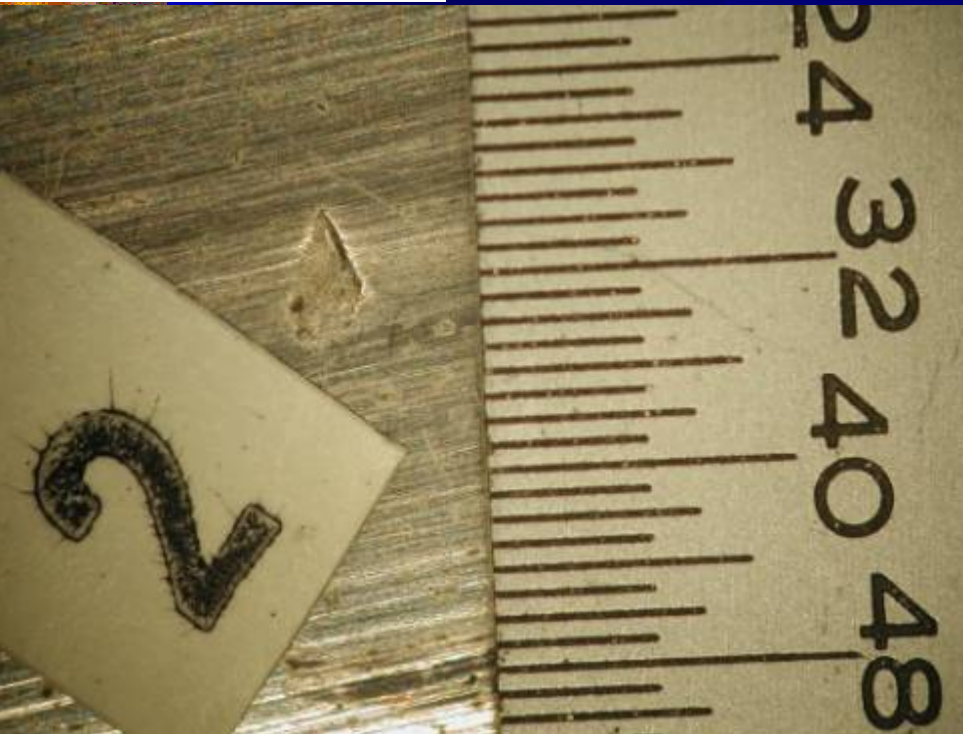
Before Repair

Defect Measured  
0.012" to 0.017" in Depth

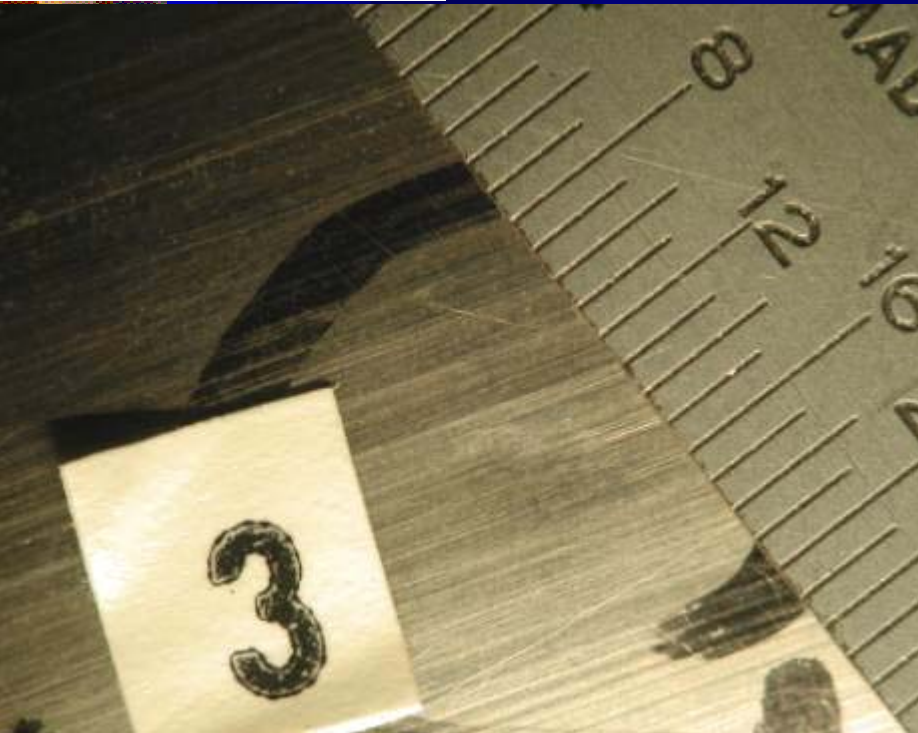
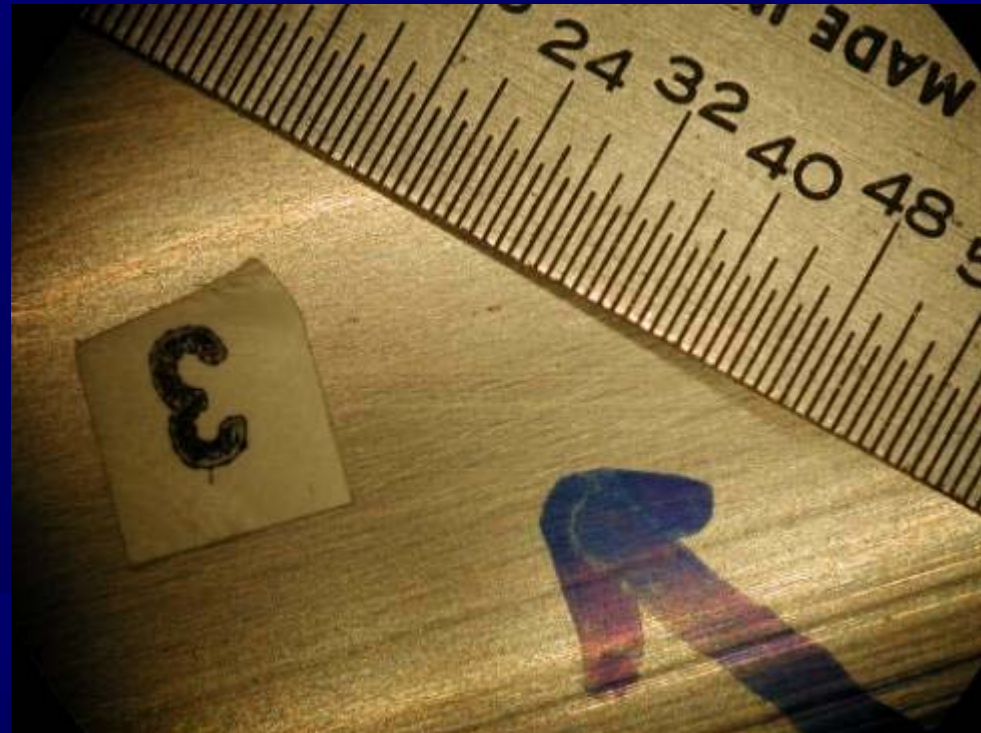
Before Repair

Defect Measured  
0.006" Maximum Depth

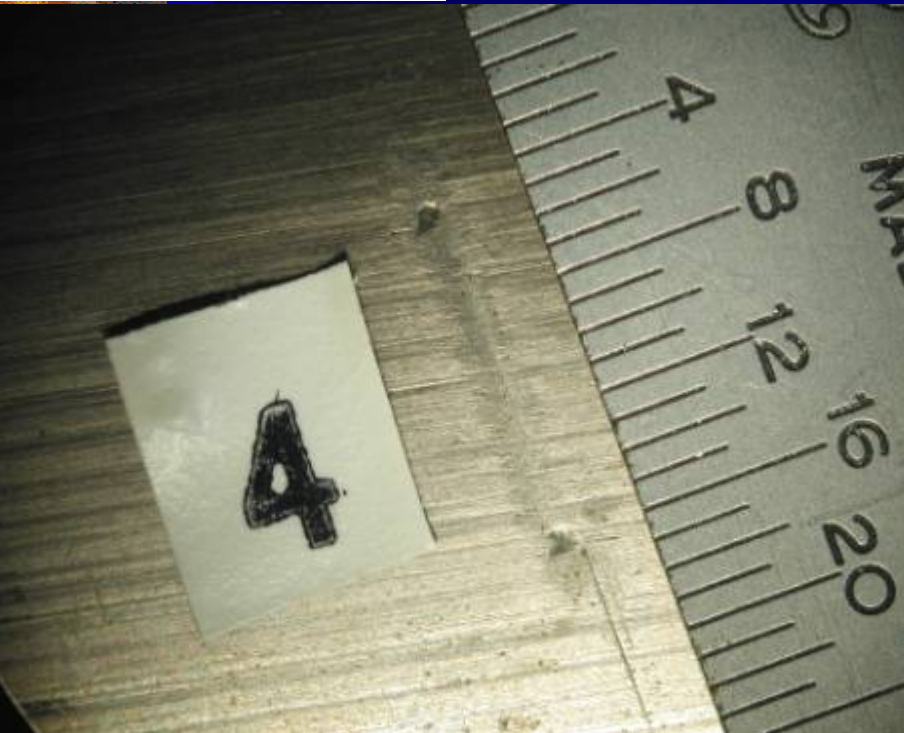
Before Repair

Defect Measured  
0.003" to 0.013" in Depth

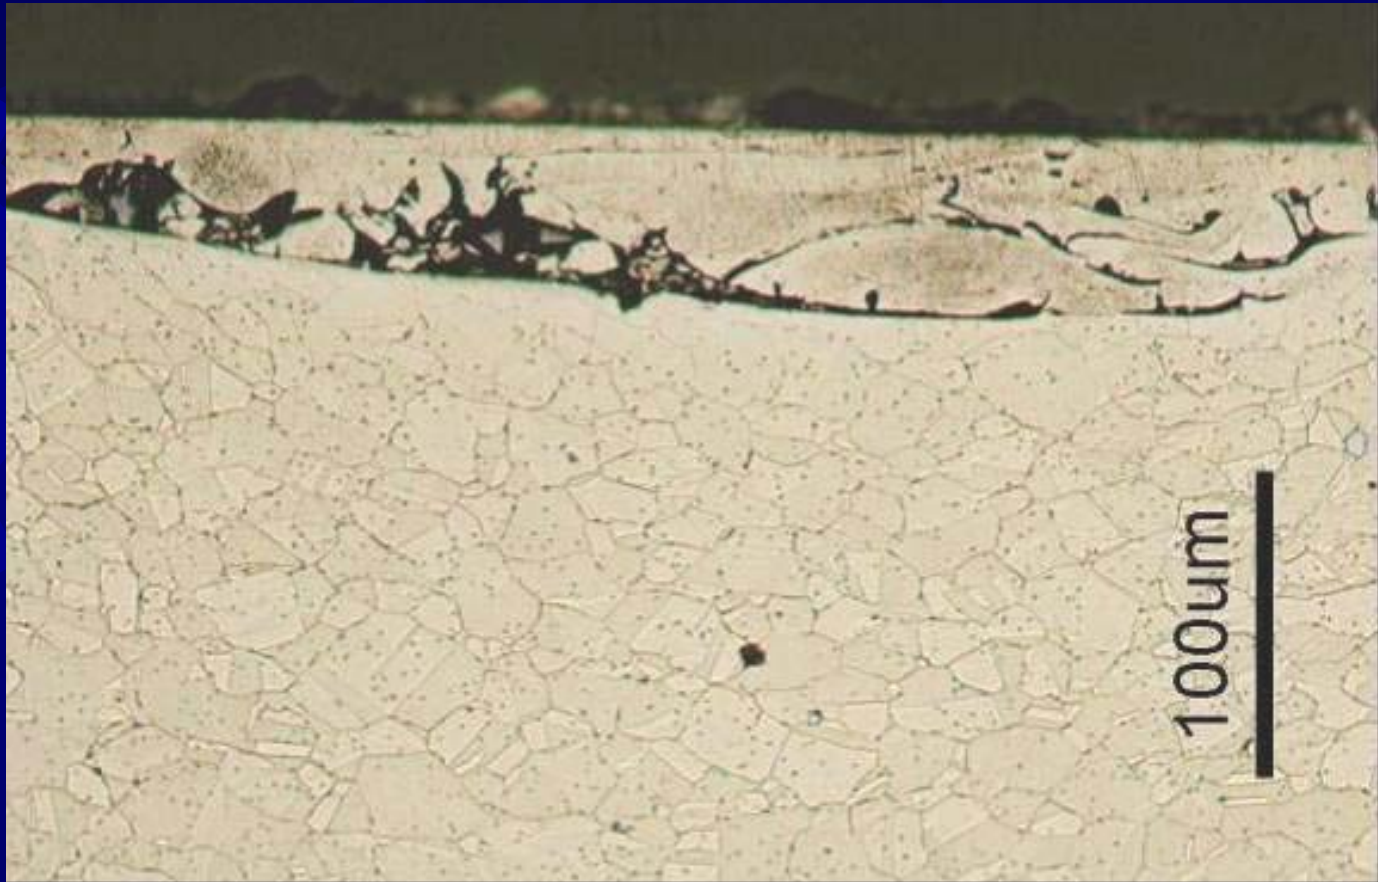
# ***ESD Repair Section #4***

- Identified voids and microcracks within narrow groove repair area and corrosion after seawater immersion
- Simulated defect study identified improvements in ESD repair with less severe defect geometry
- Additional research need to identify NDE methods to assure optimum repair quality

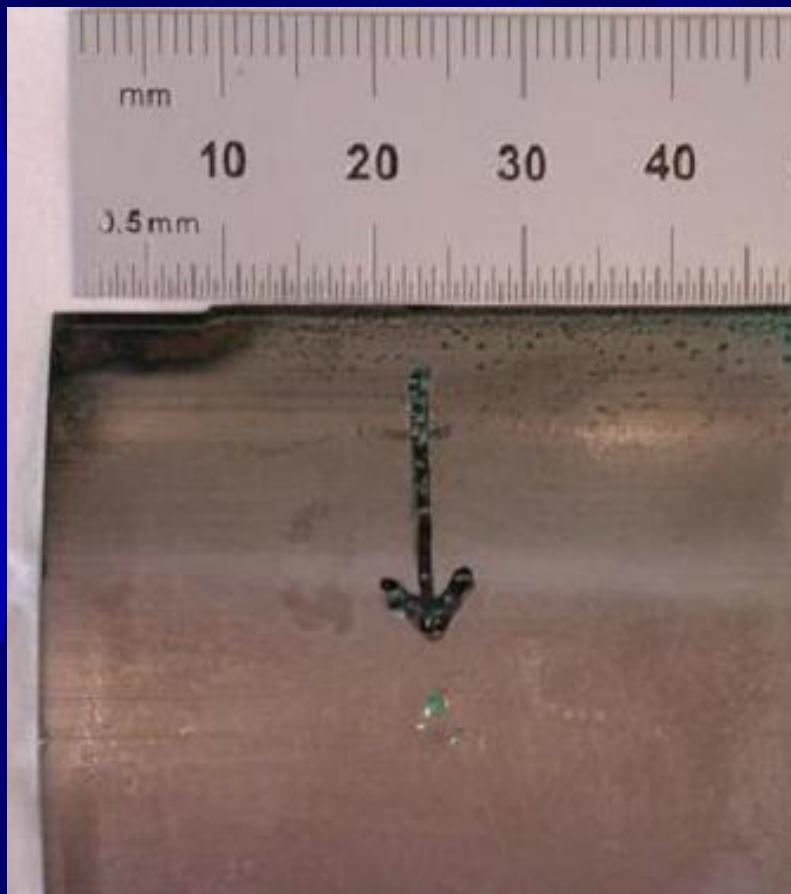
Section #1

# ***ESD Repair Sections After 127 Days in Seawater***

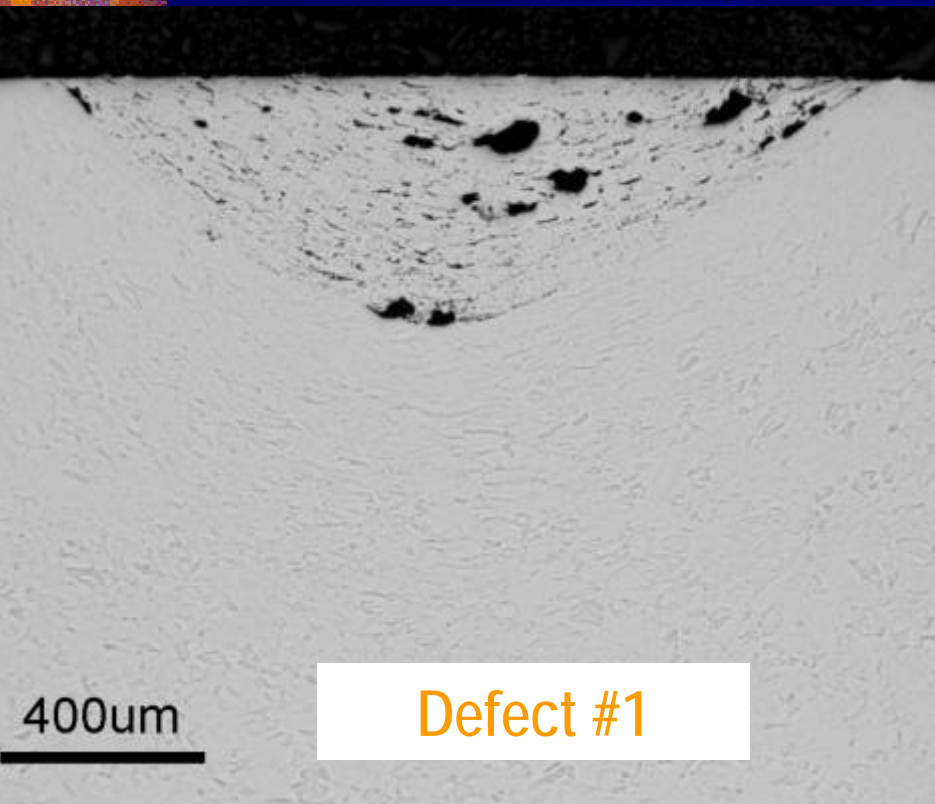
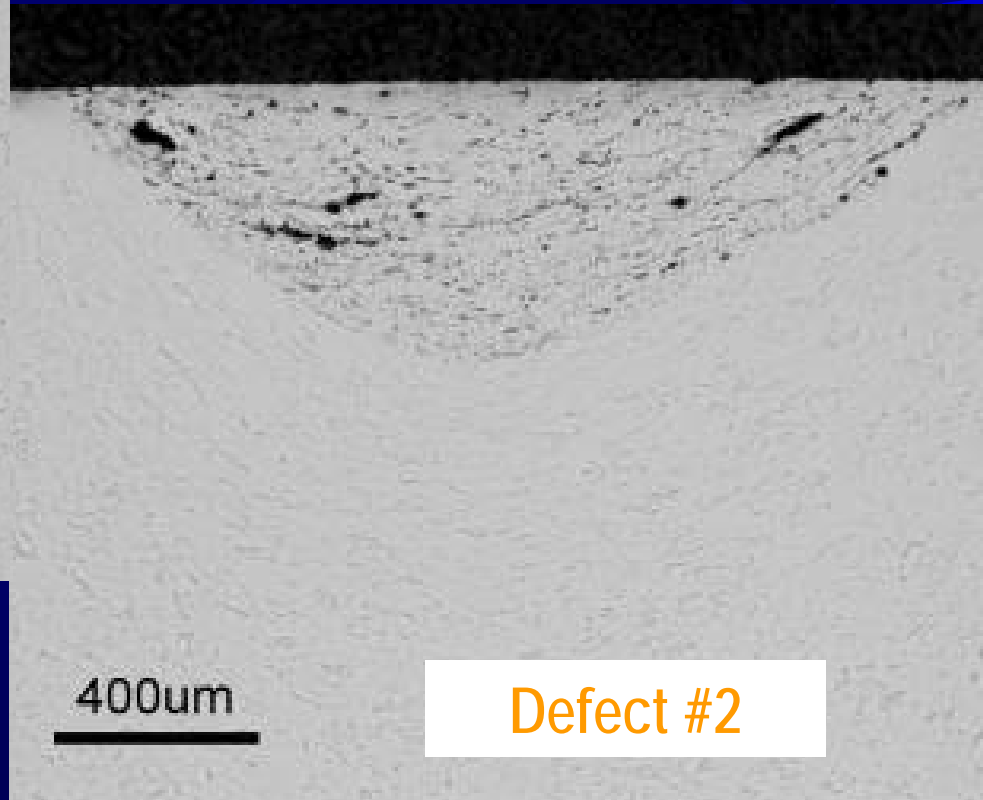
# *Blunt Chisel Defects*

## *ESD Repaired with Alloy 400*

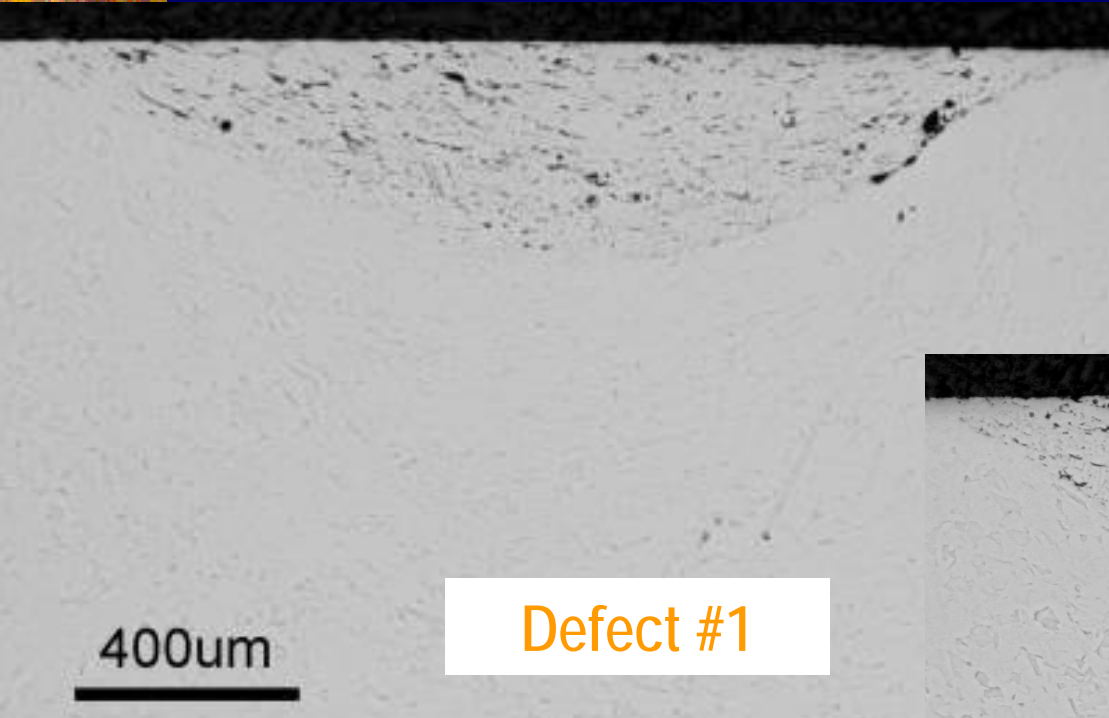
Defect #1

# *Blunt Chisel Defects Rounded Out with Dremel Tool ESD Repaired with Alloy 400*

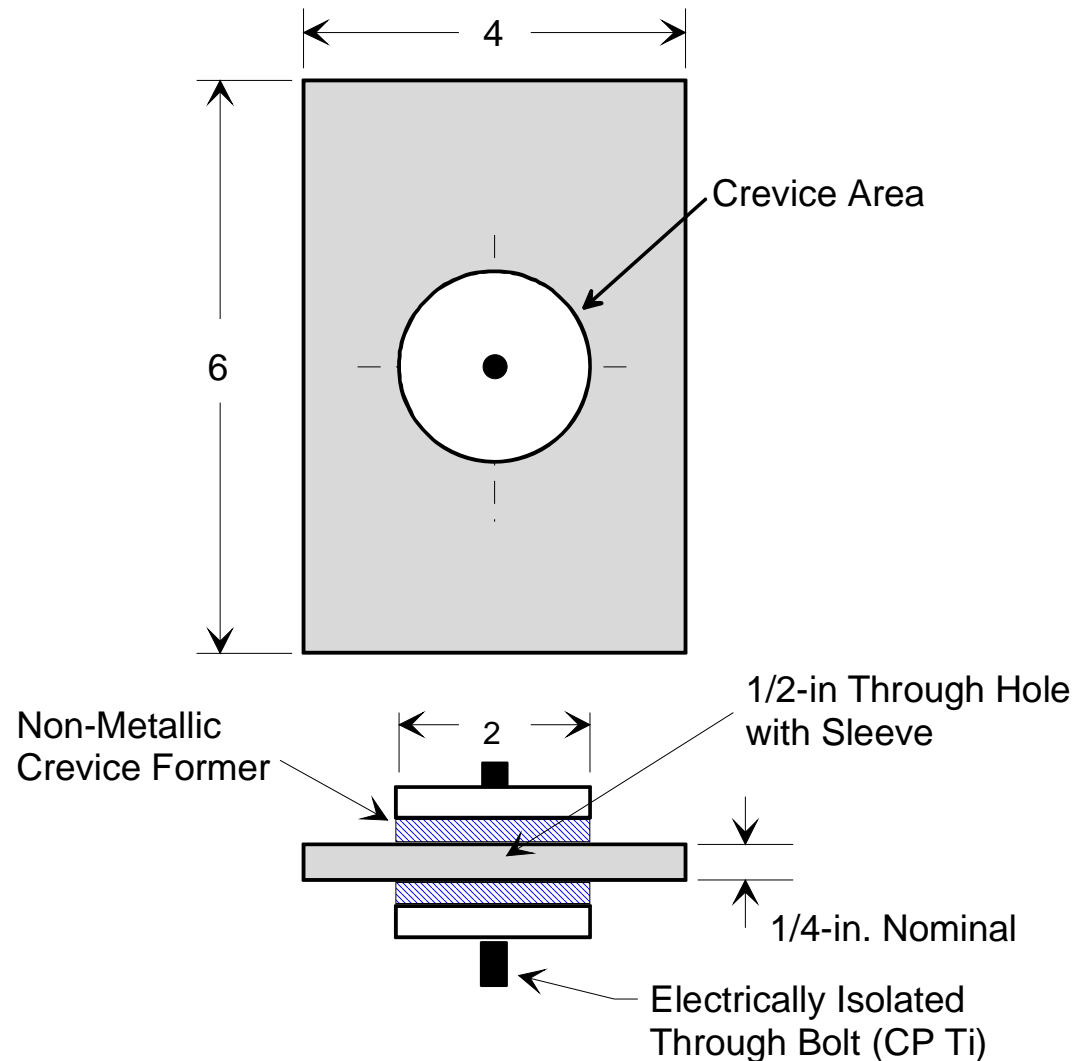
## Crevice Corrosion Testing in Natural Seawater

- ESD Coatings of Alloy 686, C276, and 59 Applied on Alloy 625 Panels
- Control Specimens Include Uncoated Alloy 686, C276, 59, and 625
- Triplicate Specimens Exposed per Condition for **180** and **365** Days in Filtered, Natural Seawater Immersion

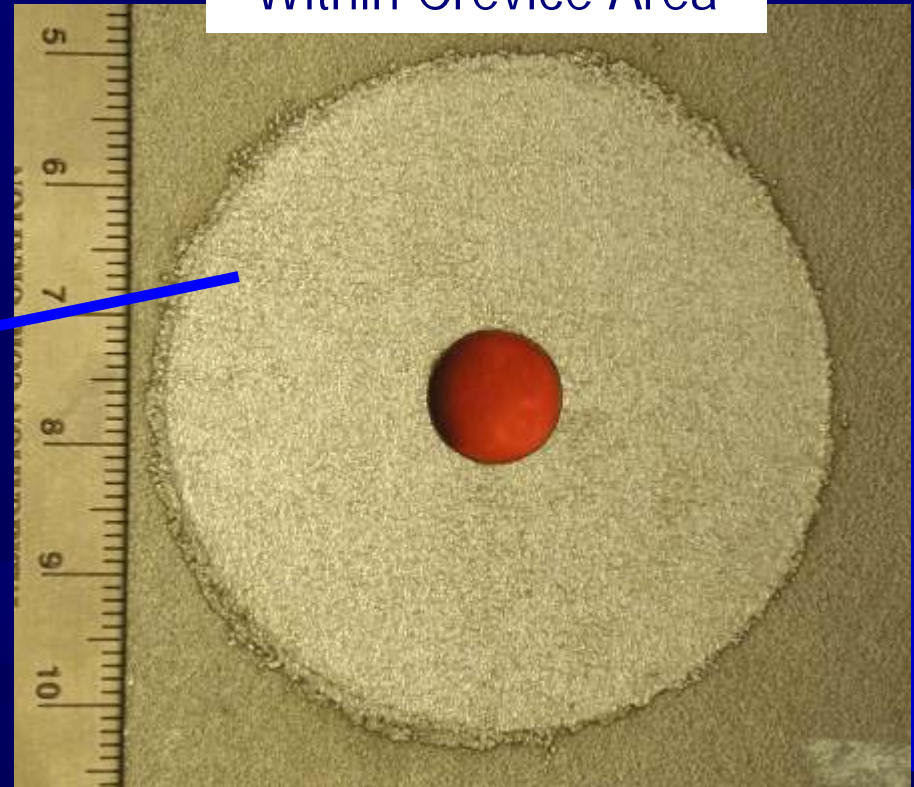
ESD Coating Applied  
Within Crevice Area

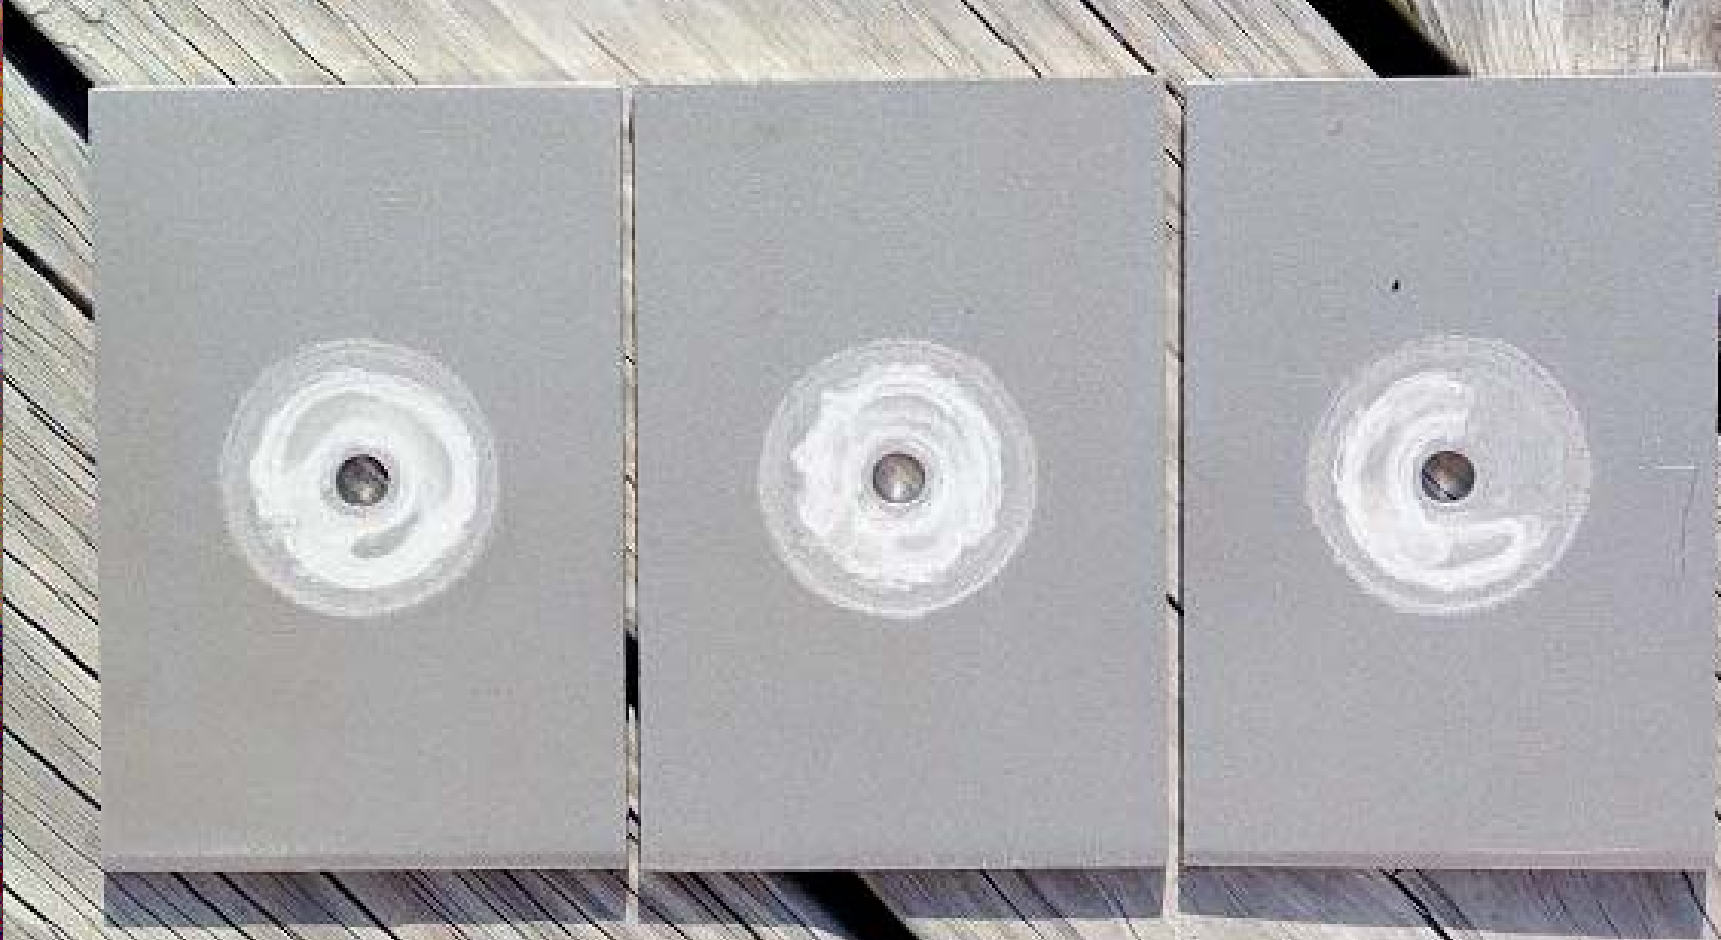
# *ESD Alloy C276 Coated Specimens After 180 Days in Natural Seawater*

- ESD Alloy C276 Coated Specimens Showed Crevice Susceptibility at Crevice Sites
  - Corrosion initiated between 9 and 14 days' immersion
  - Maximum depth of attack = 0.005 in. (0.13 mm)
- ESD Alloys 686 and 59 on 625 & Wrought Control Specimens of Alloys 625, 59, 686, and C276 Remained Corrosion Resistant After 365 Days

Maximum Depth of Attack = 0.005 in. (0.13 mm)  
Initiated After 9-14 Days' Immersion
